**DEPARTMENT OF TRANSPORTATION****DIVISION OF ENGINEERING SERVICES**

Contract #: 04-0120F4Cty: SF/ALA Rte: 80 PM: 13.2/13.9File #: 69.28**WELDING INSPECTION REPORT****Resident Engineer:** Pursell, Gary**Address:** 333 Burma Road**City:** Oakland, CA 94607**Report No:** WIR-000173**Date Inspected:** 18-May-2007**Project Name:** SAS Superstructure**OSM Arrival Time:** 800**Prime Contractor:** American Bridge/Fluor Enterprises, a JV**OSM Departure Time:** 1730**Contractor:** Zhenhua Port Machinery Company, Ltd (ZPMC), Changxing Island **Location:** Shanghai, China**CWI Name:** Wei Huang**CWI Present:** Yes No**Inspected CWI report:** Yes No N/A**Rod Oven in Use:** Yes No N/A**Electrode to specification:** Yes No N/A**Weld Procedures Followed:** Yes No N/A**Qualified Welders:** Yes No N/A**Verified Joint Fit-up:** Yes No N/A**Approved Drawings:** Yes No N/A**Approved WPS:** Yes No N/A**Delayed / Cancelled:** Yes No N/A**Bridge No:** 34-0006**Component:** 52, 55**Summary of Items Observed:**

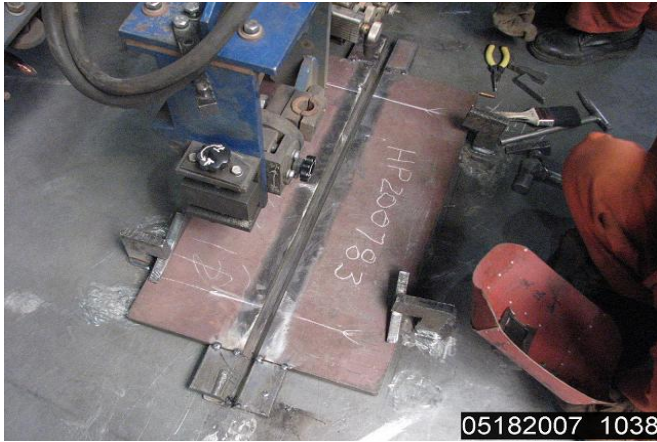
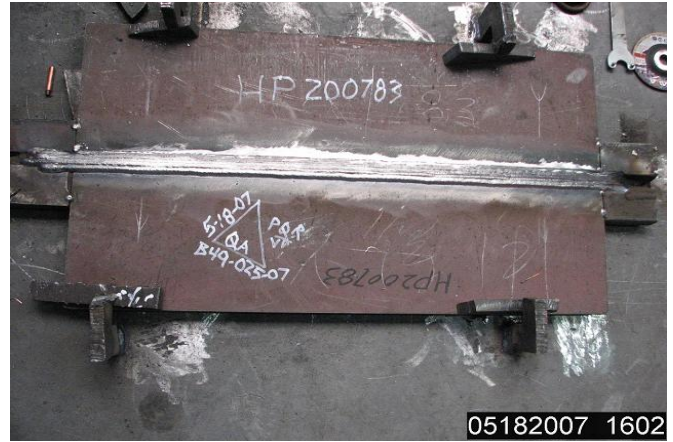
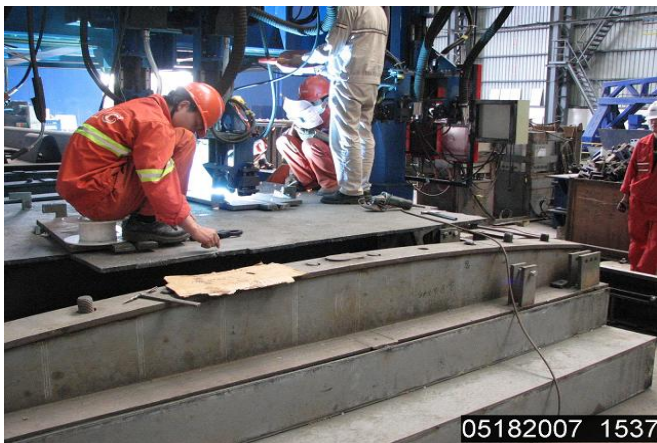
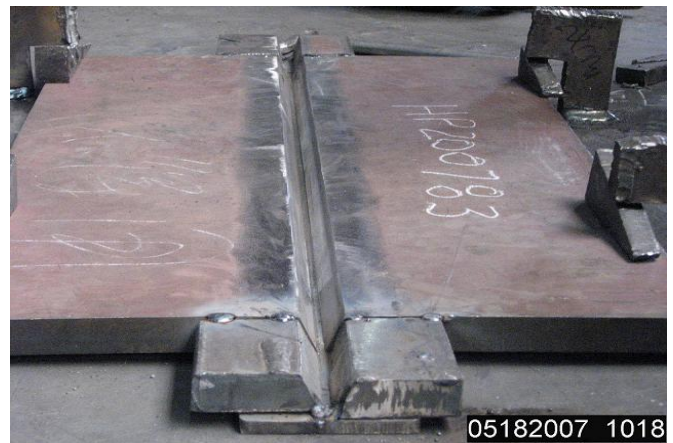
At 1000 hours, Caltrans QA Inspector witnessed ZPMC welder, Mr. Xiang Jie perform gas metal arc welding (GMAW) procedure qualification record (PQR), HP200783 test. Caltrans QA observed ZPMC QA Inspector, Mr. Wei Huang and two associates monitoring and supervising the testing per AWS 5.13 criteria; amperages, voltages, travel speeds, preheat and interpass temperatures. Also present during testing, American Bridge/Fluor representative, Mr. Craig Knop. The test plate material type and thickness is identified as A709 Gr.345T2, 25 mm with A709 Gr.345T2, 20 mm thick backing. The test plate groove preparation was observed to have an approximately 6 mm root opening with a 45 degree groove angle. The PQR testing was performed in the 1G position. The welding consumable is identified as a 1/4 mm electrode, classification ER70S6, brand name JM-56, and specification AWS A5.18. Caltrans QA inspector recorded welding parameters, one (1) through twenty (20) weld passes. Caltrans QA verified that the welding parameters taken by ZPMC QC inspector appeared to be accurate and in accordance with the contract documents. Caltrans QA observed that the ZPMC testing location for wind velocity, appear to be in conformance with AWS D1.5, paragraph 4.14.3 requirements. The completed PQR test plate was visually inspected by, Mr. Wei Huang and accepted. Mr. Wei Huang informed Caltrans QA of the inspection results. Caltrans QA observed that the finished weld appeared to comply with contract documents. Caltrans QA lot number B49-025-07 was assigned to the test plate for traceability. See Caltrans Welding Witness Report, TL-6032, dated May 18, 2007 for additional information.
